Inspection Report

Property Address:
777 Reliable Lane
Maryville TN 37801

Reliable Inspections of Tennessee, Inc.

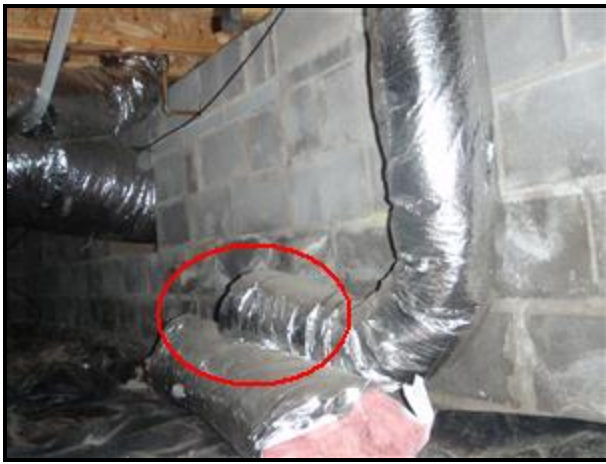
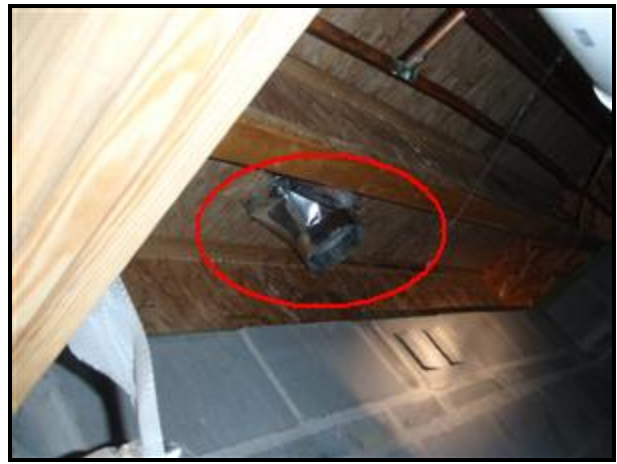
4.3 Picture 1

**4.3** Ductwork disconnected in the crawlspace. Recommend HVAC contractor make the necessary repairs to prevent wasted energy.

- 🏠 Ductwork disconnected in the crawlspace. Recommend HVAC contractor make the necessary repairs to prevent wasted energy.

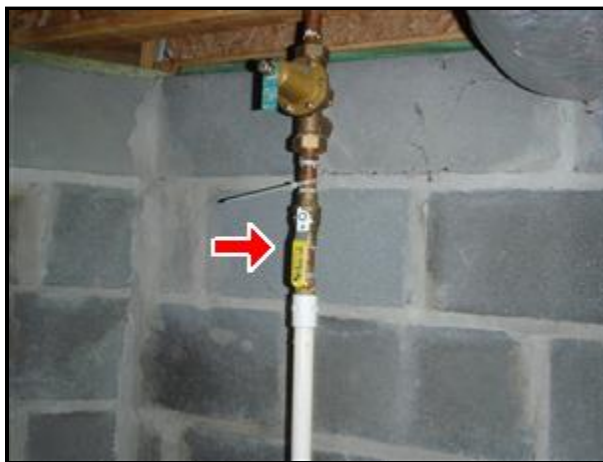
5.0 Picture 1

5.0 The main shut off is the yellow lever located underneath in the crawlspace. This is for your information.

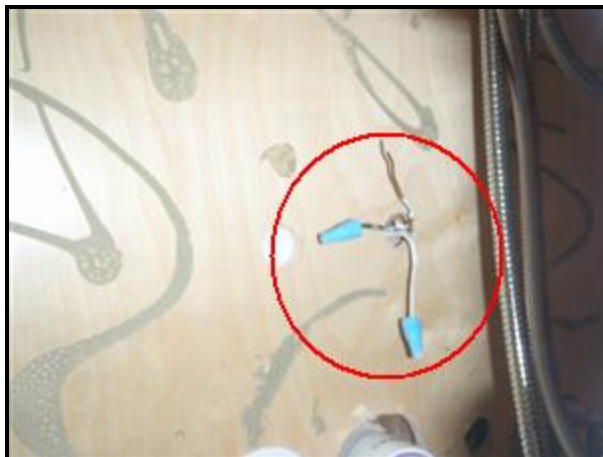
6.3 Picture 1

6.3 There is some exposed wiring underneath the kitchen sink, most likely for a food disposer. These wires should be properly connected to a receptacle inside an approved box. A licensed electrician should make this repair.

- 🏠 There is some exposed wiring underneath the kitchen sink, most likely for a food disposer. These wires should be properly connected to a receptacle inside an approved box. A licensed electrician should make this repair.

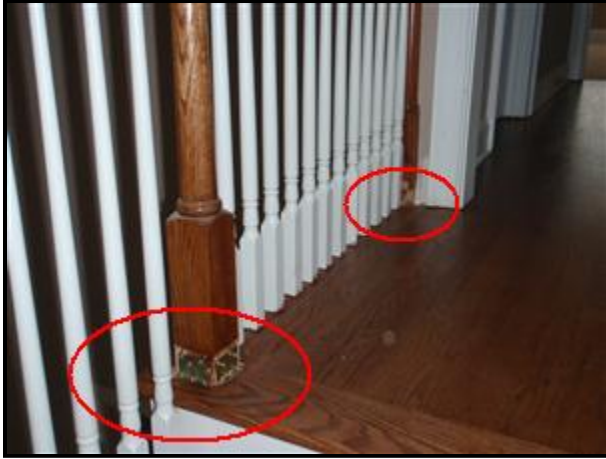
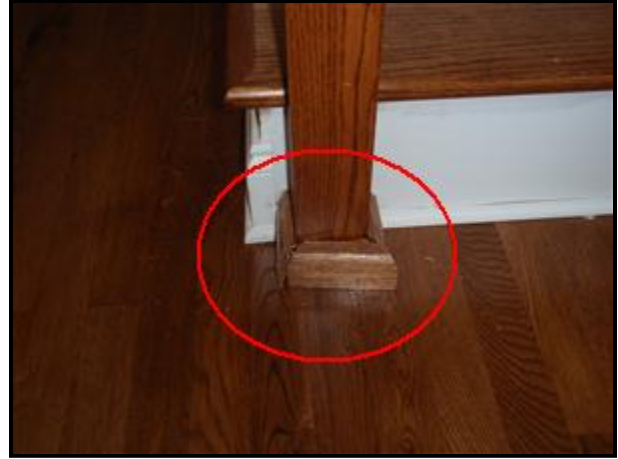
8.3 Picture 1

8.3 There is some missing trim work on the stairway. Recommend a qualified trim carpenter finish this work.

There is some missing trim work on the stairway. Recommend a qualified trim carpenter finish this work.
